COMPETITIVE QUOTE

FOR ASBESTOS ABATEMENT

**Fort Dodge City Hall
Priority 5.0 Renovation**

**ASBESTOS CONTAINING MATERIAL &
LEAD-BASED PAINT INSPECTION**

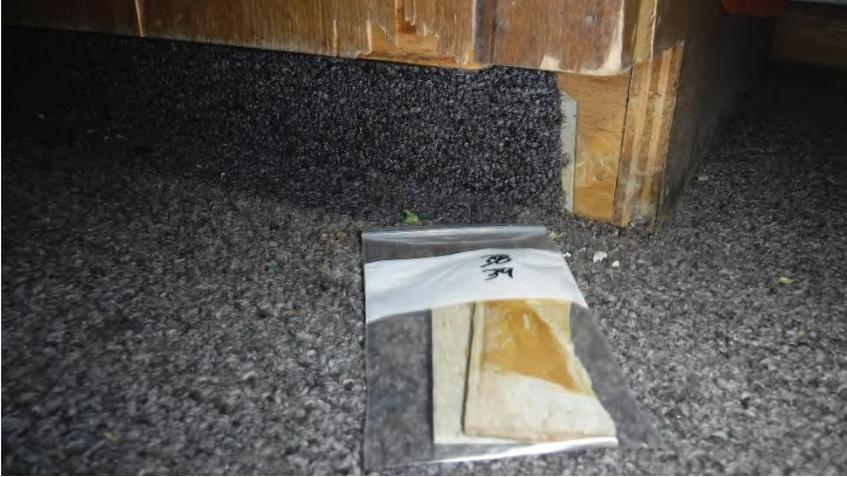
<p>3/19/19 – 4/3/2019 Photographer: Jacob Huxford</p>	<p>ACM Inspection Fort Dodge City Hall</p>
<p><u>Description:</u> Tile Cove Base – Gray</p> <p><u>Location:</u> Economic Development – Kitchen – e211J</p> <p><u>Sample:</u> 19JH031938</p> <p>Photo #1</p>

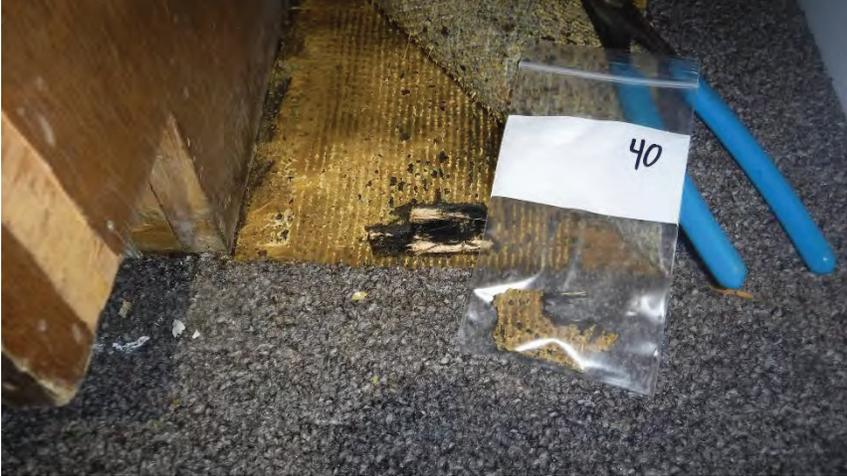
<p><u>Description:</u> Floor Tile Mastic - Black</p> <p><u>Location:</u> Economic Development – Kitchen – e211J</p> <p><u>Sample:</u> 19JH031940</p> <p>Photo #2</p>

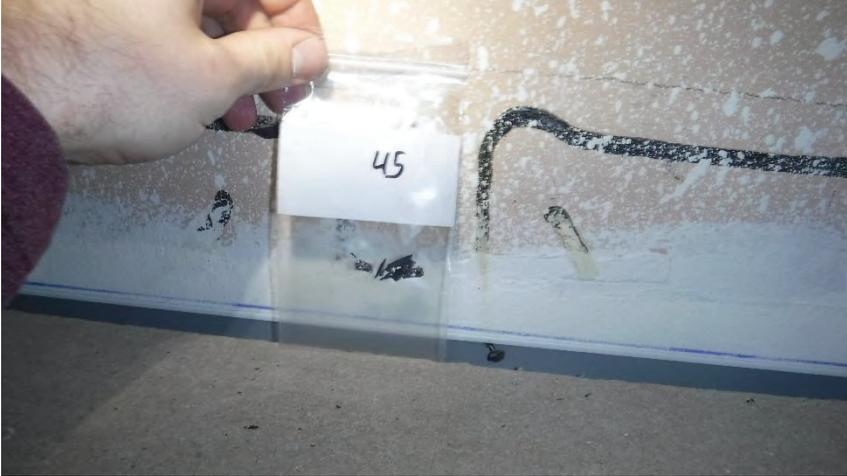
<p><u>Description:</u> Wall Adhesive – Black</p> <p><u>Location:</u> Economic Development – Waiting Room – e211A</p> <p><u>Sample:</u> 19JH031945</p> <p>Photo #3</p>

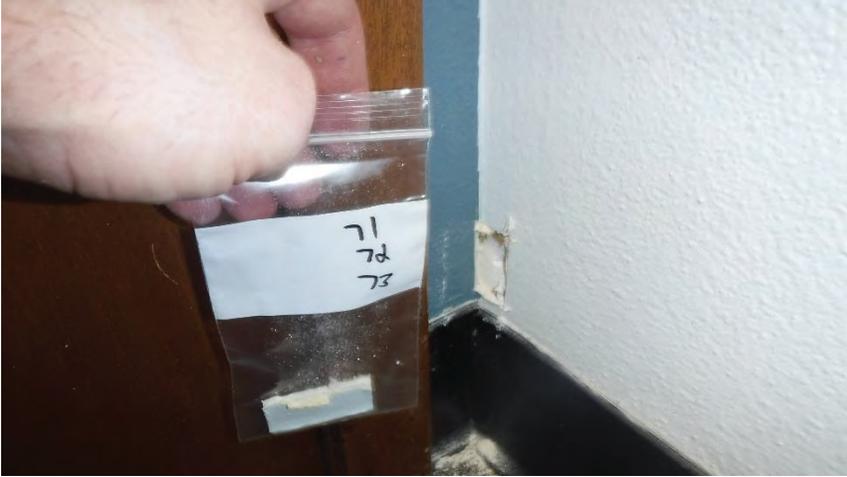
<p>3/19/19 – 4/3/2019 Photographer: Jacob Huxford</p>	<p>ACM Inspection Fort Dodge City Hall</p>
<p><u>Description:</u> Drywall Joint Compound – White</p> <p><u>Location:</u> Inspections/Engineering – Lobby – e205A</p> <p><u>Sample:</u> 19JH031972</p> <p>Photo #4</p>

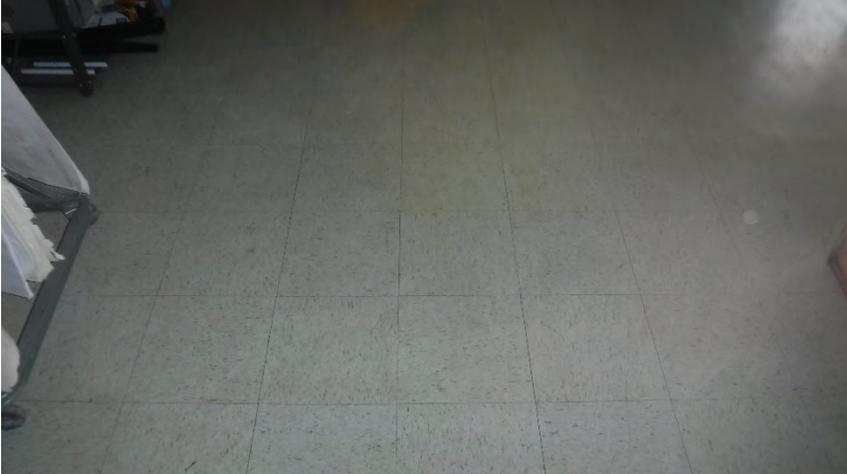
<p><u>Description:</u> 12" x 12" Floor Tile – Cream w/ Tan Streaks</p> <p><u>Location:</u> Inspections/Engineering – e205B</p> <p><u>Sample:</u> 19JH031980</p> <p>Photo #5</p>

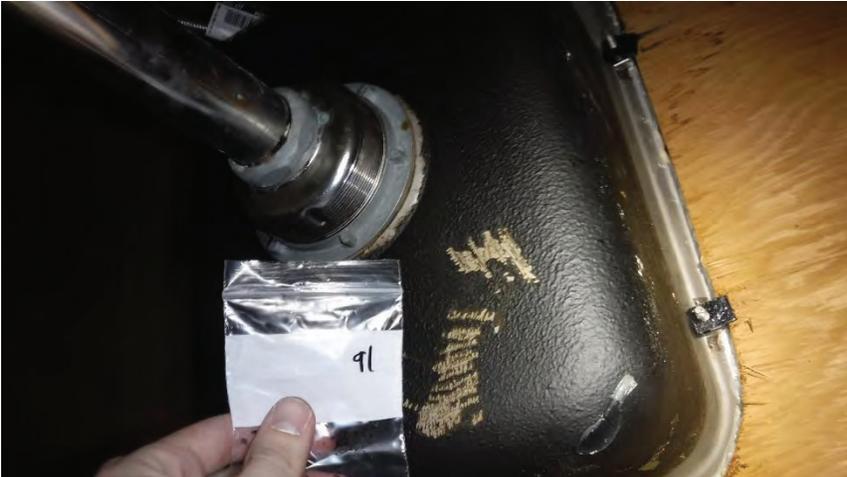
<p><u>Description:</u> Sink Undercoat – White</p> <p><u>Location:</u> Human Resources – Storage – e203F</p> <p><u>Sample:</u> 19JH031991</p> <p>Photo #6</p>

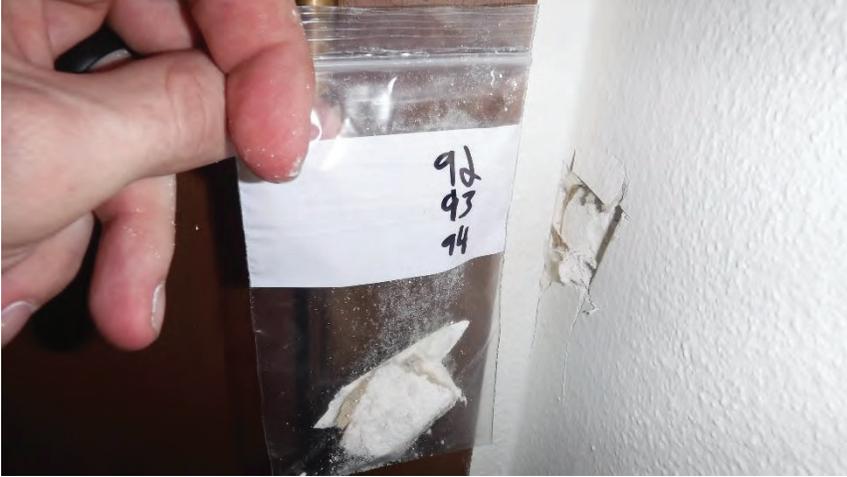
<p>3/19/19 – 4/3/2019 Photographer: Jacob Huxford</p>	<p>ACM Inspection Fort Dodge City Hall</p>
<p><u>Description:</u> Drywall Joint Compound – White</p> <p><u>Location:</u> Human Resources – Storage – e203F</p> <p><u>Sample:</u> 19JH031992</p> <p>Photo #7</p>

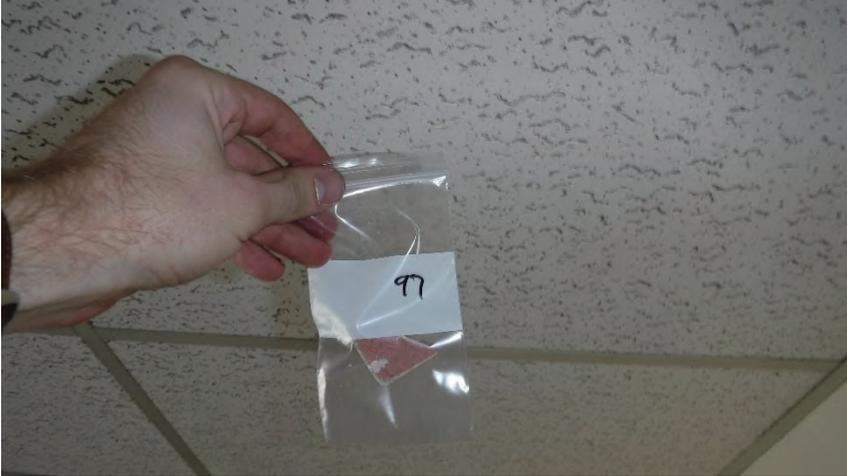
<p><u>Description:</u> Ceiling Tile - White</p> <p><u>Location:</u> Human Resources – Storage – e203F</p> <p><u>Sample:</u> 19JH031997</p> <p>Photo #8</p>

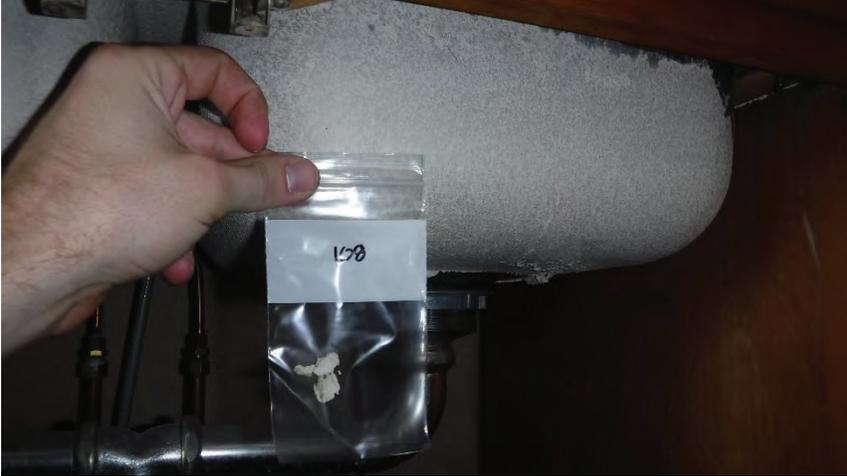
<p><u>Description:</u> Sink Undercoat - White</p> <p><u>Location:</u> Storage – e147</p> <p><u>Sample:</u> 19JH0319108</p> <p>Photo #9</p>

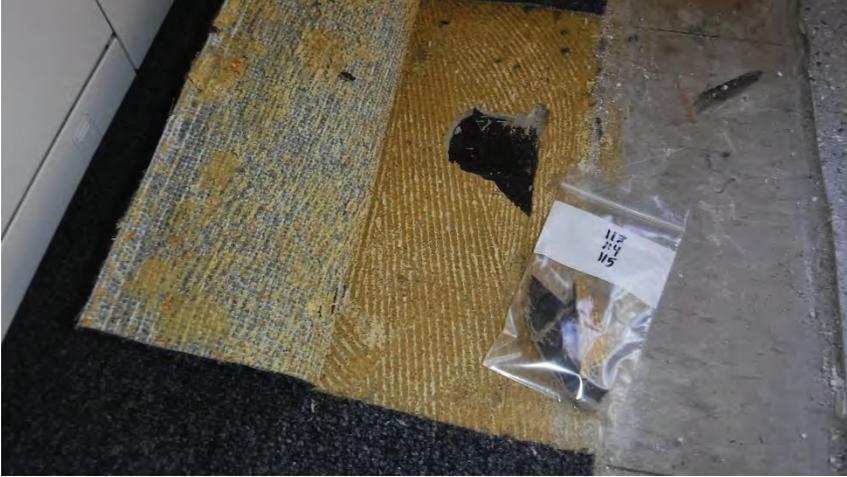
<p>3/19/19 – 4/3/2019 Photographer: Jacob Huxford</p>	<p>ACM Inspection Fort Dodge City Hall</p>
<p><u>Description:</u> 12" x 12" Floor Tile – Brown and Floor Tile Mastic – Black</p> <p><u>Location:</u> Breakroom – e143A and Conference Room (David) – e143B</p> <p><u>Sample:</u> 19JH0319113 and 19JH0319114</p> <p>Photo #10</p>

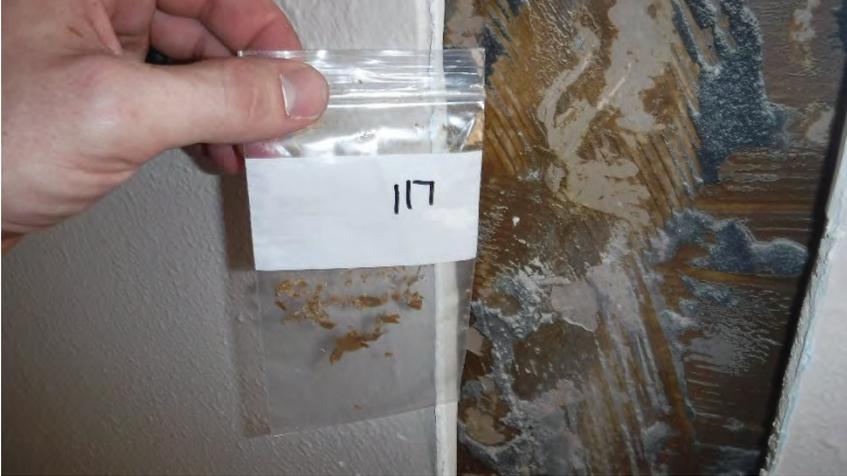
<p>A photograph showing a section of a floor tile with a yellowish-brown fibrous texture. A small, irregular piece of black mastic is attached to the tile. Next to the tile is a clear plastic bag containing a sample, with a white label that has the numbers 112, 113, and 115 written on it.</p>
<p><u>Description:</u> Wall Mastic – Brown</p> <p><u>Location:</u> Breakroom – e143A</p> <p><u>Sample:</u> 19JH0319117</p> <p>Photo #11</p>

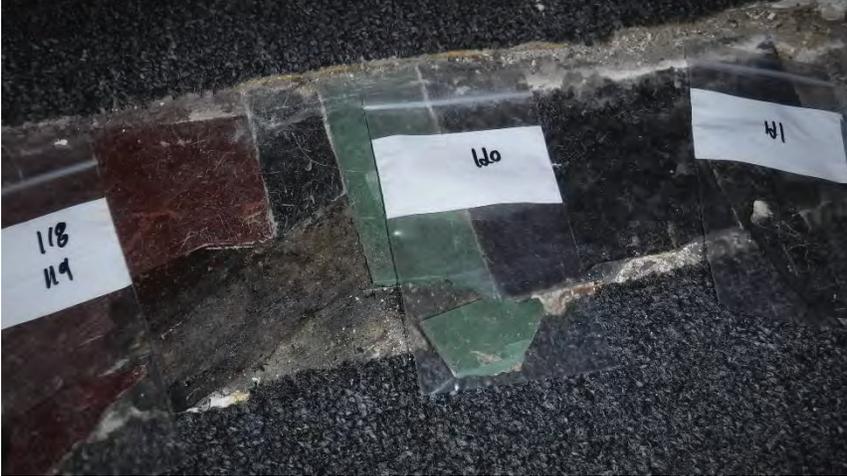
<p><u>Description:</u> Floor Tile – Maroon, Green, and Black</p> <p><u>Location:</u> Breakroom – e143A</p> <p><u>Sample:</u> 19JH0319118, 19JH0319120, and 19JH0319121</p> <p>Photo #12</p>

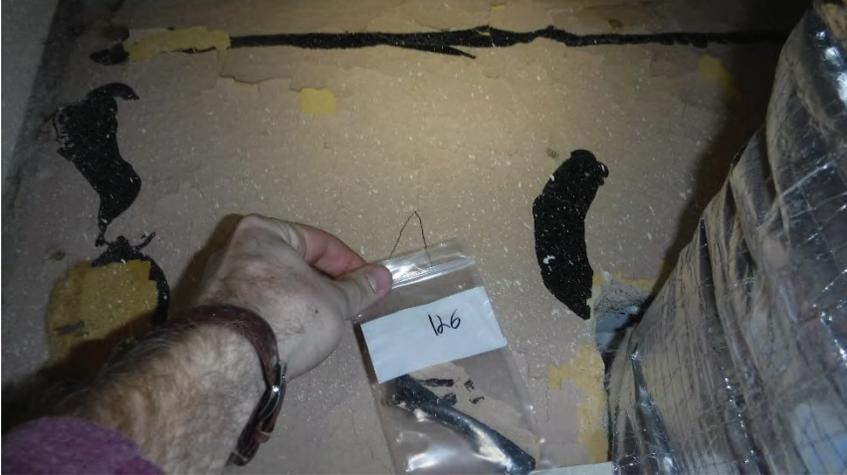
<p>3/19/19 – 4/3/2019 Photographer: Jacob Huxford</p>	<p style="text-align: center;">ACM Inspection Fort Dodge City Hall</p>
<p><u>Description:</u> Wall Mastic – Black</p> <p><u>Location:</u> Breakroom – e143A</p> <p><u>Sample:</u> 19JH0319126</p> <p>Photo #13</p>

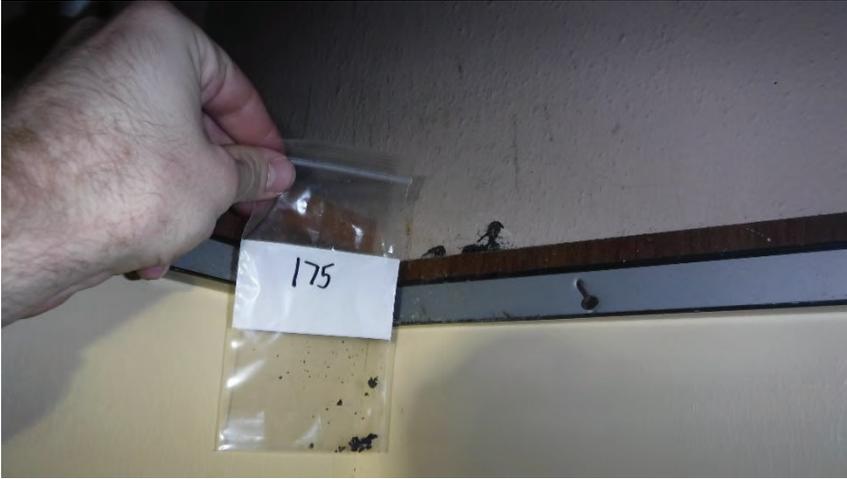
<p><u>Description:</u> Wall Panel Mastic – Black</p> <p><u>Location:</u> City Administrator – Storage/Attorney (Ryan) – e135</p> <p><u>Sample:</u> 19JH0319175</p> <p>Photo #14</p>

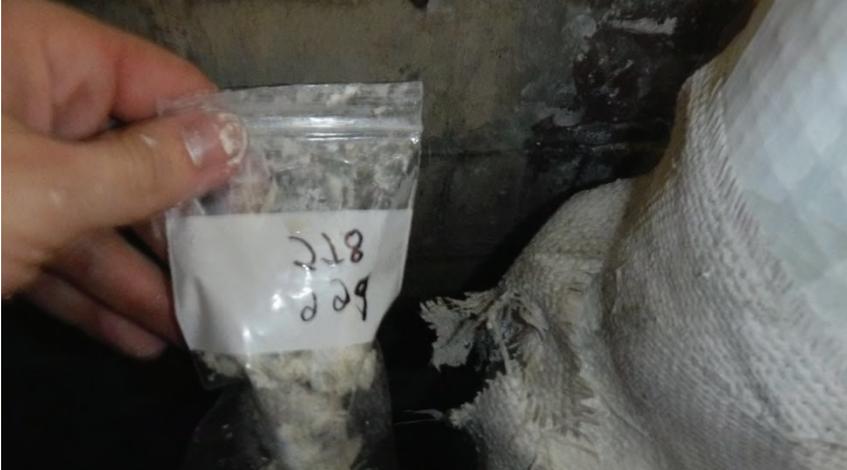
<p><u>Description:</u> Pipe Insulation – White</p> <p><u>Location:</u> Electrical Room – e158</p> <p><u>Sample:</u> 19JH0319229 ABC</p> <p>Photo #15</p>

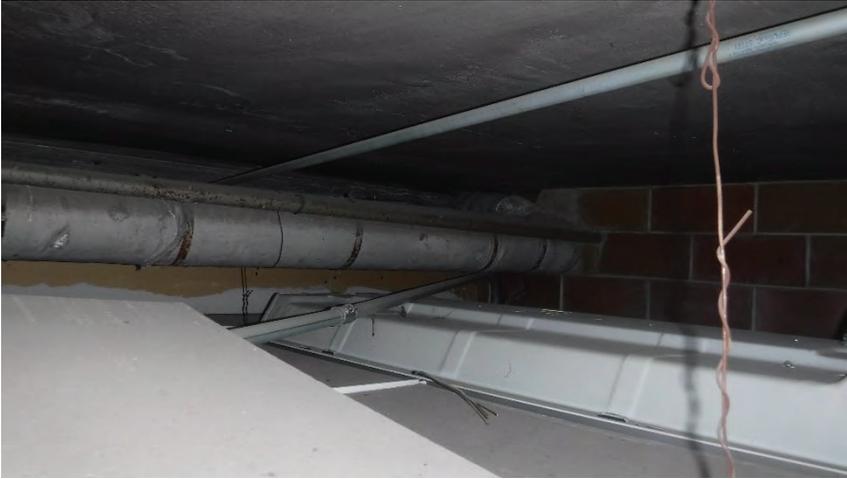
<p>3/19/19 – 4/3/2019 Photographer: Jacob Huxford</p>	<p>ACM Inspection Fort Dodge City Hall</p>
<p><u>Description:</u> Pipe Insulation – White</p> <p><u>Location:</u> Electrical Room – e158</p> <p><u>Sample:</u> 19JH0319229 ABC</p> <p>Photo #16</p>

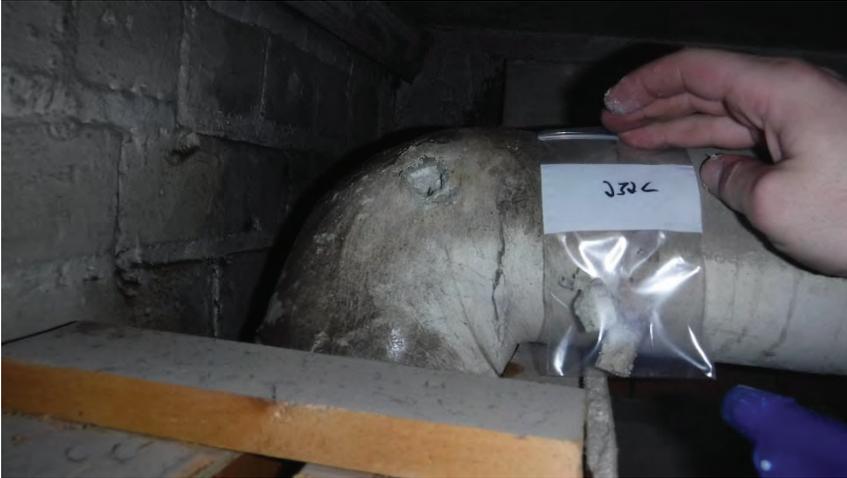
A photograph showing a large pipe wrapped in white insulation, situated in a dark, confined space. A white metal tray is visible in the foreground, and a red string is hanging from the ceiling.
<p><u>Description:</u> Mudded Joint – White</p> <p><u>Location:</u> Electrical Room – e158</p> <p><u>Sample:</u> 19JH0319232 ABC</p> <p>Photo #17</p>

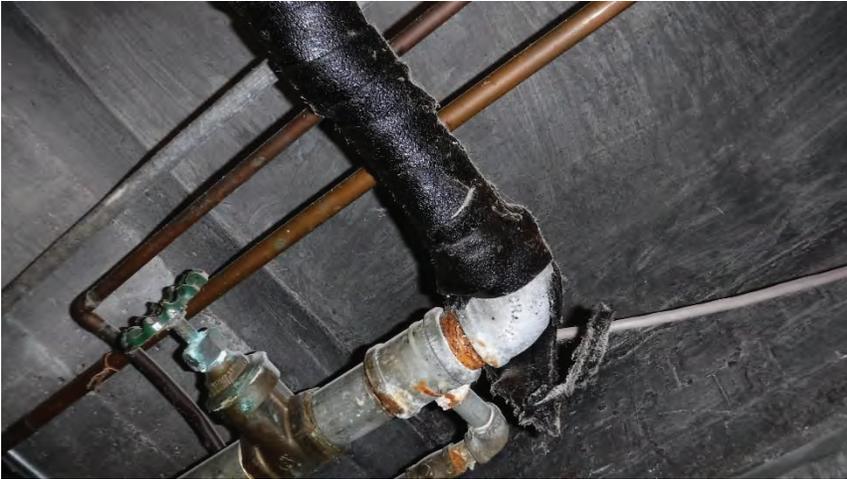
A close-up photograph of a mudded joint on a pipe. A person's hand is holding a clear plastic bag with a white label that has 'J32' written on it, positioned to collect a sample from the joint.
<p><u>Description:</u> Pipe Wrap - Black</p> <p><u>Location:</u> Storage e13A</p> <p><u>Sample:</u> 19JH0319261</p> <p>Photo #18</p>

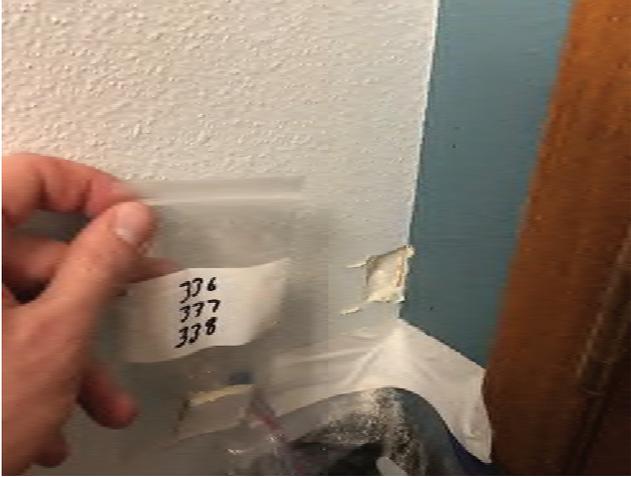
<p>3/19/19 – 4/3/2019 Photographer: Jacob Huxford</p>	<p>ACM Inspection Fort Dodge City Hall</p>
<p><u>Description:</u> Drywall Joint Compound – White</p> <p><u>Location:</u> Engineering/Inspections – e205C</p> <p><u>Sample:</u> 19JH0403337</p> <p>Photo #19</p>

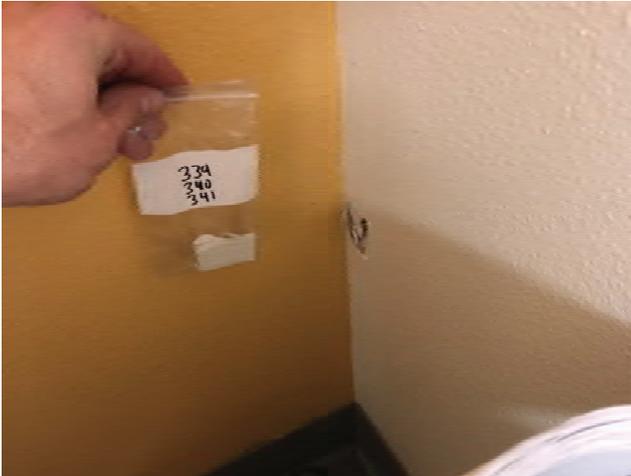
<p><u>Description:</u> Drywall Joint Compound – White</p> <p><u>Location:</u> Engineering/Inspections – e205E</p> <p><u>Sample:</u> 19JH0403340</p> <p>Photo #20</p>

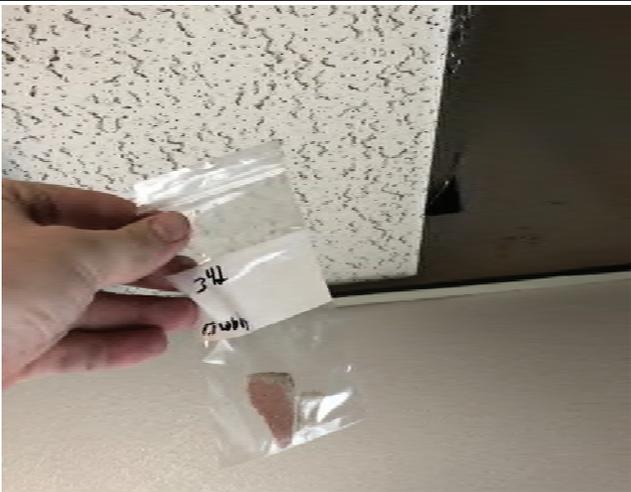
<p><u>Description:</u> Ceiling Tile - White</p> <p><u>Location:</u> Human Resources – Storage – e203E</p> <p><u>Sample:</u> 19JH0403342</p> <p>Photo #21</p>

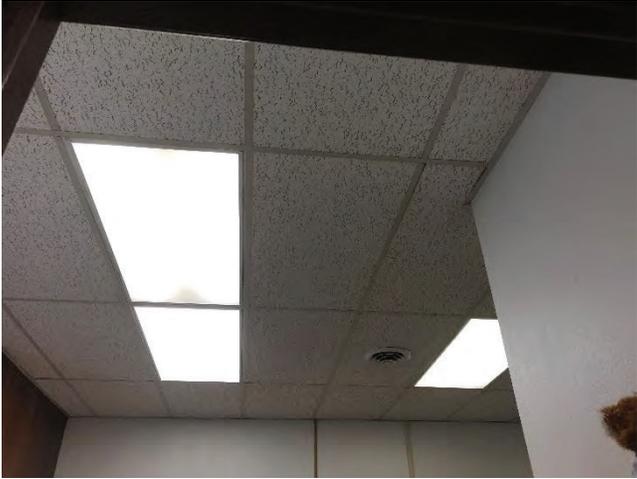
<p>3/19/19 – 4/3/2019 Photographer: Jacob Huxford</p>	<p>ACM Inspection Fort Dodge City Hall</p>
<p><u>Description:</u> Ceiling Tile - White</p> <p><u>Location:</u> Human Resources – Storage – e203A</p> <p><u>Sample:</u> 19JH0403343</p> <p>Photo #22</p>

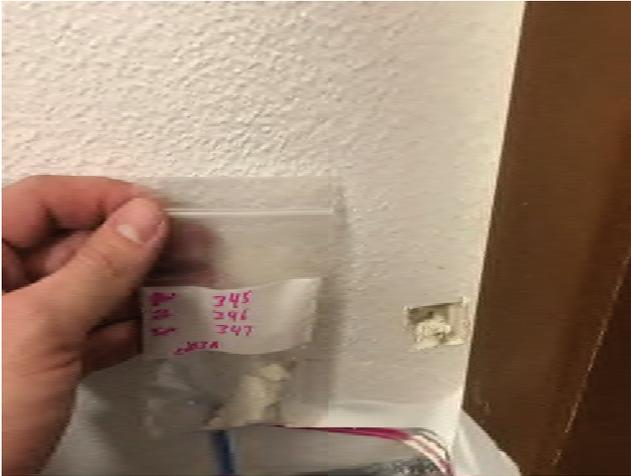
<p><u>Description:</u> Drywall Joint Compound – White</p> <p><u>Location:</u> Human Resources – Storage – e203A</p> <p><u>Sample:</u> 19JH0403346</p> <p>Photo #23</p>

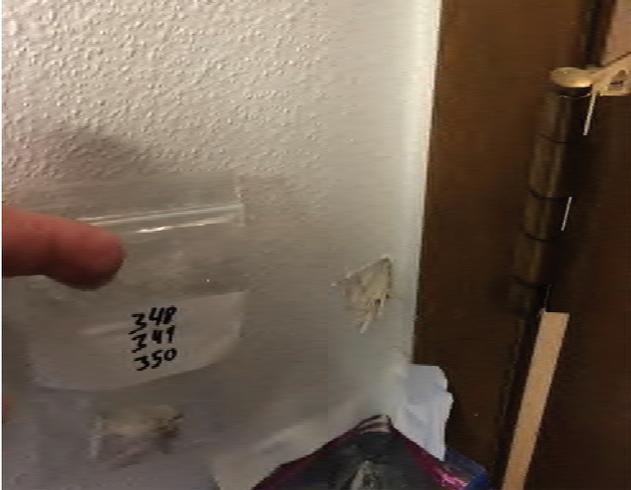
<p><u>Description:</u> Drywall Joint Compound – White</p> <p><u>Location:</u> Human Resources – Storage – e203E</p> <p><u>Sample:</u> 19JH0403349</p> <p>Photo #24</p>

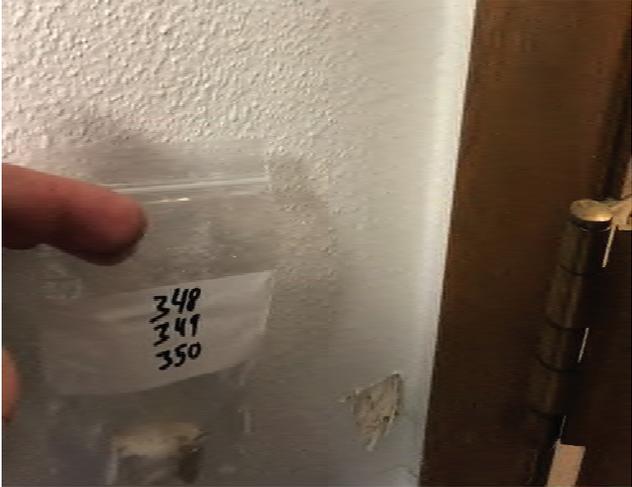
<p>3/19/19 – 4/3/2019 Photographer: Jacob Huxford</p>	<p>ACM Inspection Fort Dodge City Hall</p>
<p><u>Description:</u> Drywall Joint Compound – White</p> <p><u>Location:</u> Human Resources – Storage – e203B</p> <p><u>Sample:</u> 19JH0403352</p> <p>Photo #25</p>

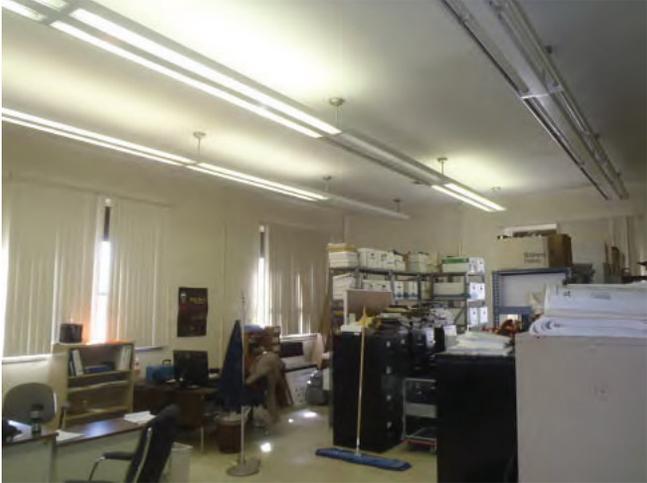
<p>3/18/19 – 3/22/19 Photographer: Tyler Silverthorn</p>	<p>LBP Inspection Fort Dodge City Hall</p>
<p><u>Component:</u> Plaster Walls and Ceiling</p> <p><u>Location:</u> Inspections Large Office</p> <p>Photo #1</p>

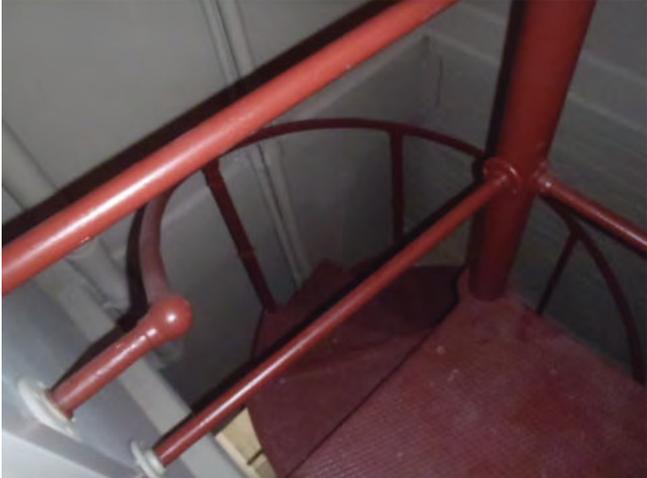
<p><u>Components:</u> Spiral Stair Components</p> <p><u>Location:</u> Spiral Staircase</p> <p>Photo #2</p>

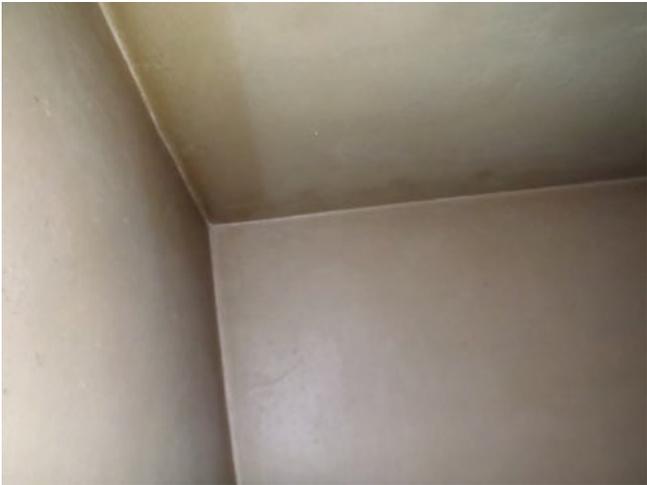
<p><u>Component:</u> Walls and Ceiling above Drop Ceiling</p> <p><u>Location:</u> Throughout</p> <p>Photo #3</p>

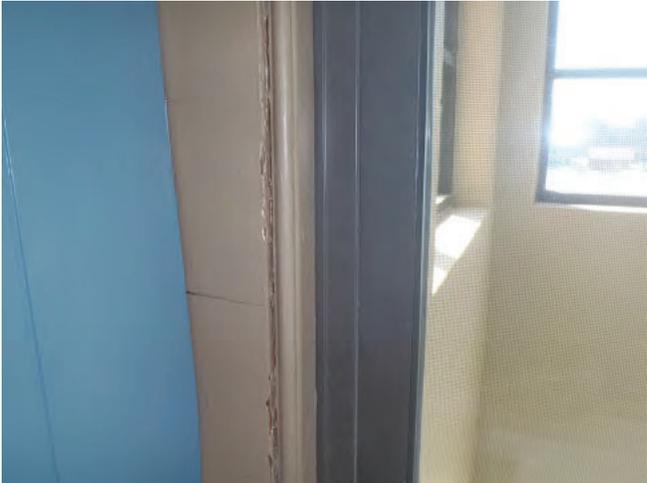
<p>3/18/19 – 3/22/19 Photographer: Tyler Silverthorn</p>	<p>LBP Inspection Fort Dodge City Hall</p>
<p><u>Component:</u> Interior Window Components</p> <p><u>Location:</u> Inspections Office 2</p> <p>Photo #4</p>

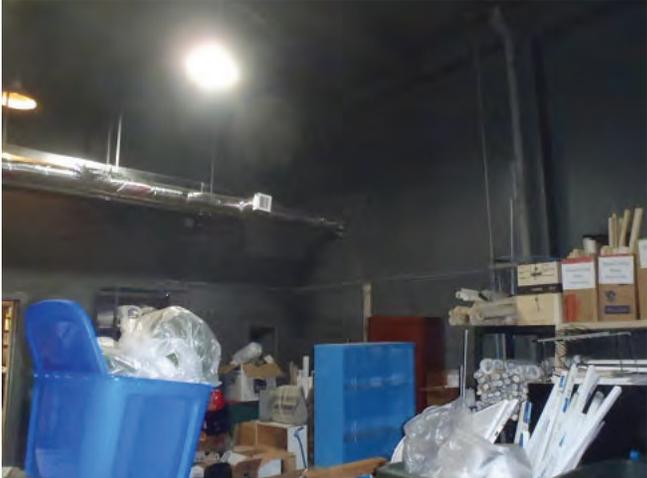
A photograph showing a close-up of a window frame and a blue door or panel. The window is partially open, showing a view of the outdoors. The wall is a light-colored, textured surface.
<p><u>Component:</u> Walls, Ceiling, and Pipe</p> <p><u>Location:</u> Econ. Devel. Storage</p> <p>Photo #5</p>

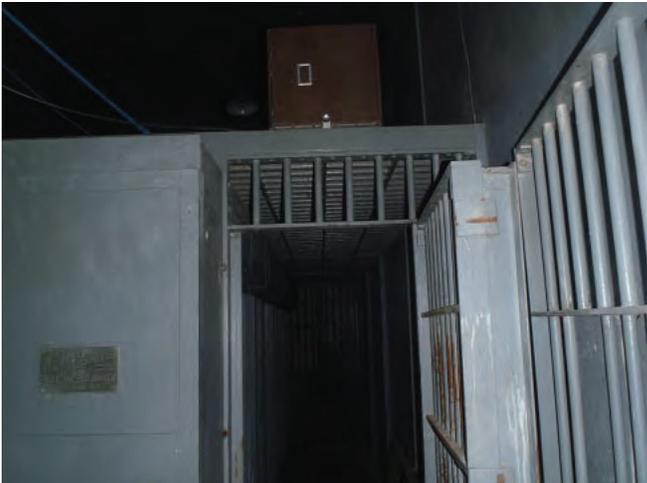
A photograph of a storage area. The ceiling is dark with exposed pipes and a bright light fixture. The floor is cluttered with various items, including a blue bin, boxes, and other materials.
<p><u>Component:</u> Jail Cell Components</p> <p><u>Location:</u> Econ. Devel. Jail</p> <p>Photo #6</p>

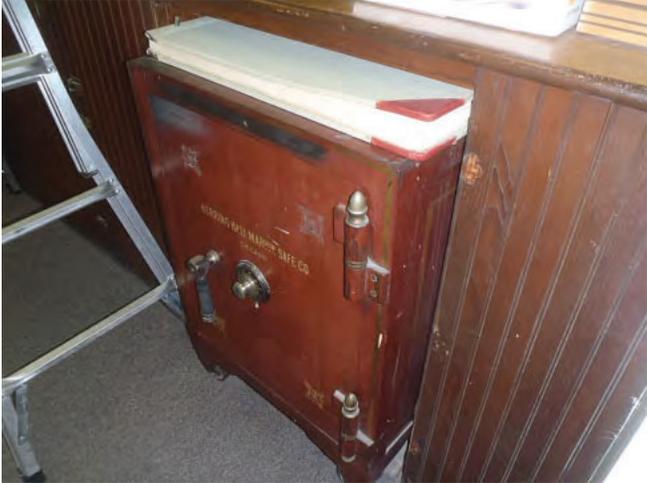
<p>3/18/19 – 3/22/19 Photographer: Tyler Silverthorn</p>	<p>LBP Inspection Fort Dodge City Hall</p>
<p><u>Component:</u> Safe Components</p> <p><u>Location:</u> Econ. Devel. N Hall</p> <p>Photo #7</p>

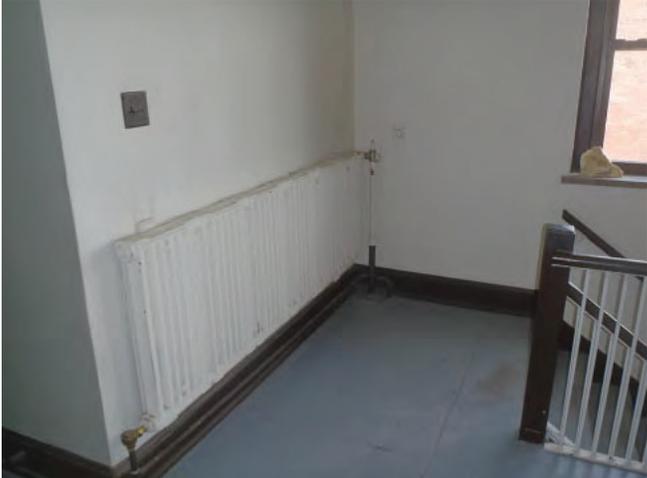
<p><u>Component:</u> Radiator and Walls</p> <p><u>Location:</u> 2nd Floor W Hall</p> <p>Photo #8</p>

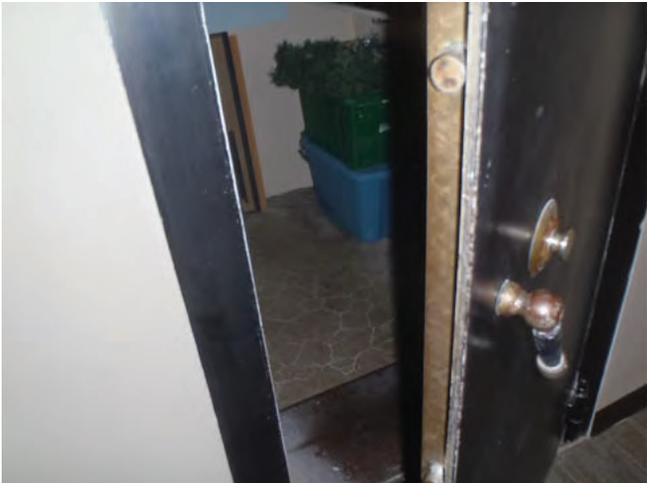
<p><u>Component:</u> Vault Door Components</p> <p><u>Location:</u> Throughout</p> <p>Photo #9</p>

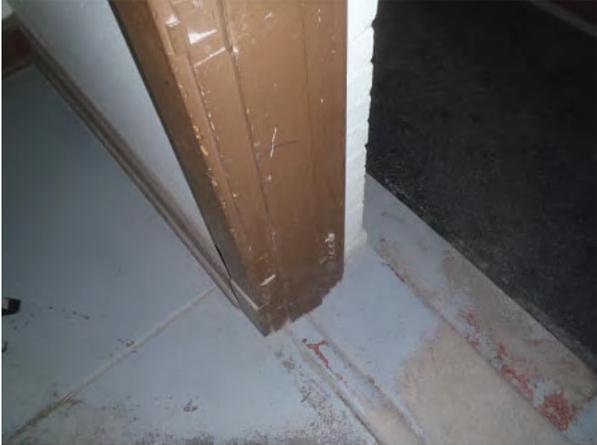
<p>3/18/19 – 3/22/19 Photographer: Tyler Silverthorn</p>	<p>LBP Inspection Fort Dodge City Hall</p>
<p><u>Component:</u> Door Stop</p> <p><u>Location:</u> SW Entry</p> <p>Photo #10</p>

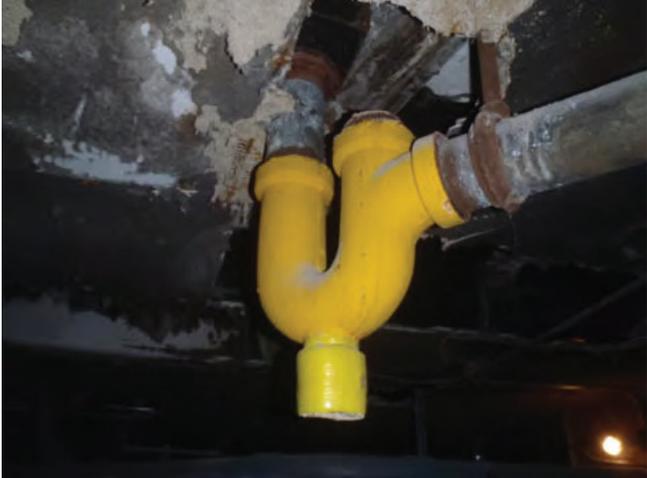
<p><u>Component:</u> Pipe</p> <p><u>Location:</u> Basement-E13B</p> <p>Photo #11</p>

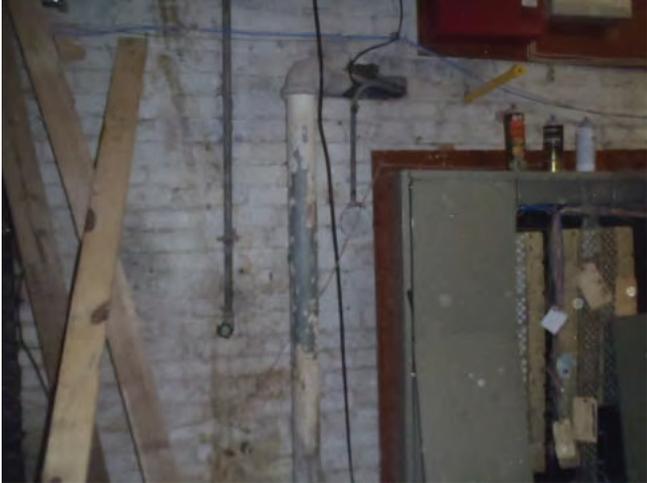
<p><u>Component:</u> Pipe</p> <p><u>Location:</u> Basement-E13A</p> <p>Photo #12</p>

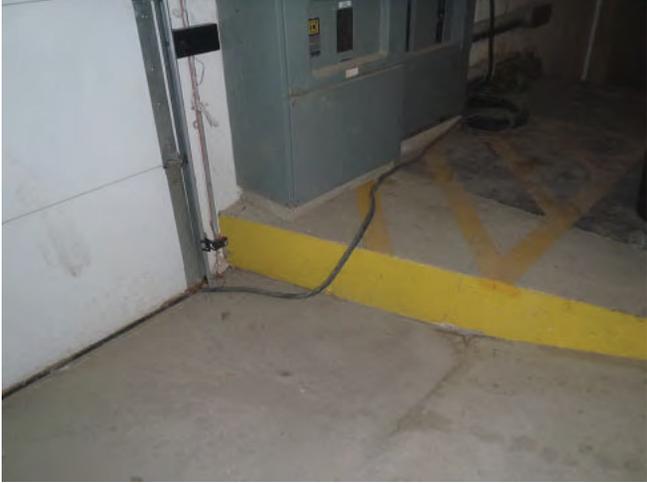
<p>3/18/19 – 3/22/19 Photographer: Tyler Silverthorn</p>	<p>LBP Inspection Fort Dodge City Hall</p>
<p><u>Component:</u> Drive In Wall Stripe</p> <p><u>Location:</u> Basement-E04</p> <p>Photo #13</p>

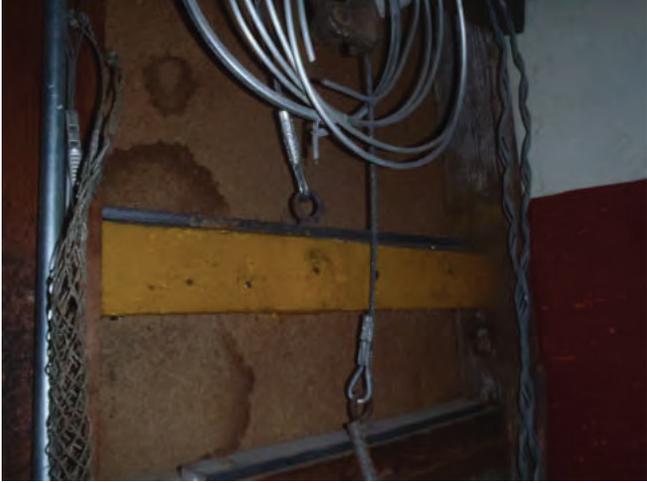
<p><u>Component:</u> Stud Cross Member</p> <p><u>Location:</u> Basement-E11</p> <p>Photo #14</p>

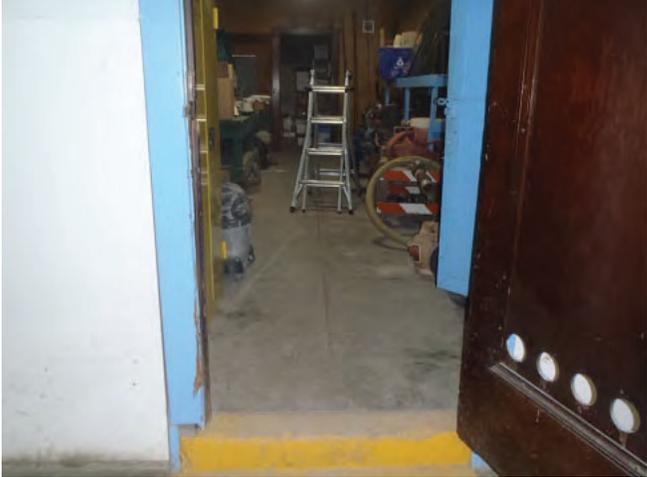
<p><u>Component:</u> Steps</p> <p><u>Location:</u> Basement-E02</p> <p>Photo #15</p>

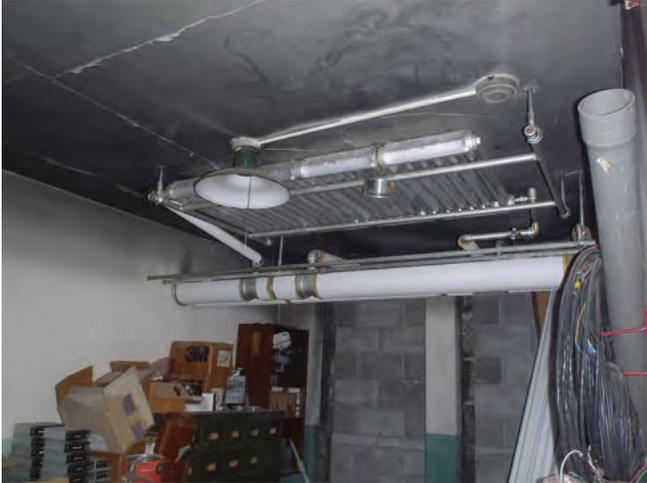
<p>3/18/19 – 3/22/19 Photographer: Tyler Silverthorn</p>	<p style="text-align: center;">LBP Inspection Fort Dodge City Hall</p>
<p><u>Component:</u> Radiator</p> <p><u>Location:</u> Basement-Throughout</p> <p>Photo #19</p>

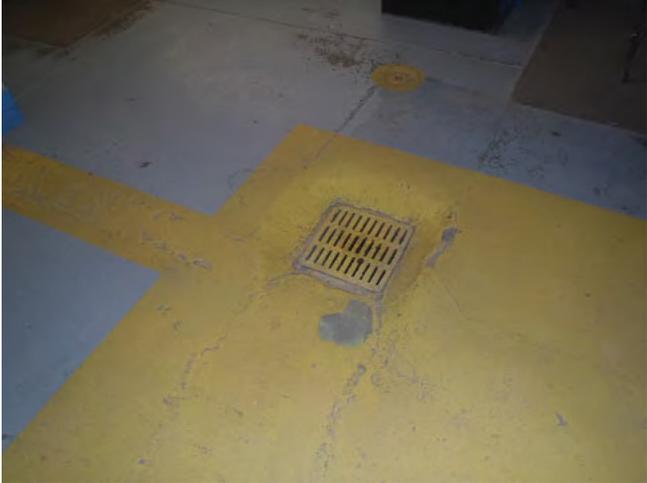
<p>A photograph of a staircase. The walls are painted a light blue color. The stairs have a blue handrail on the right side. The floor is a light-colored material, possibly concrete or tile. The staircase leads up to a dark doorway at the top.</p>
<p><u>Component:</u> Floor Stripe and Drain</p> <p><u>Location:</u> Basement-E01A</p> <p>Photo #21</p>
